# JUMBO EXPRESS

## A Scientific Approach to Understanding and Mitigating Elephant Mortality Due to Train Accidents in Rajaji National Park

An Occasional Report by Wildlife Trust of India and  
the International Fund for Animal Welfare of a Rapid Action Project on  
Understanding and Mitigating the Problem of Elephant Mortality due to Train Hits

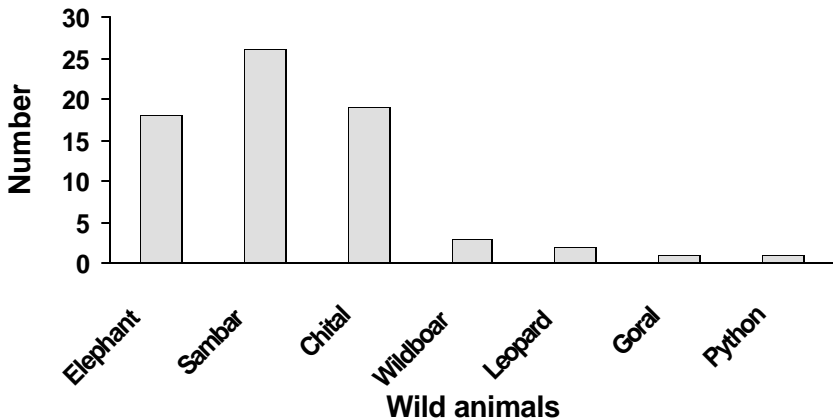
Figure 1: Wildlife mortality by train accidents in Rajaji National Park

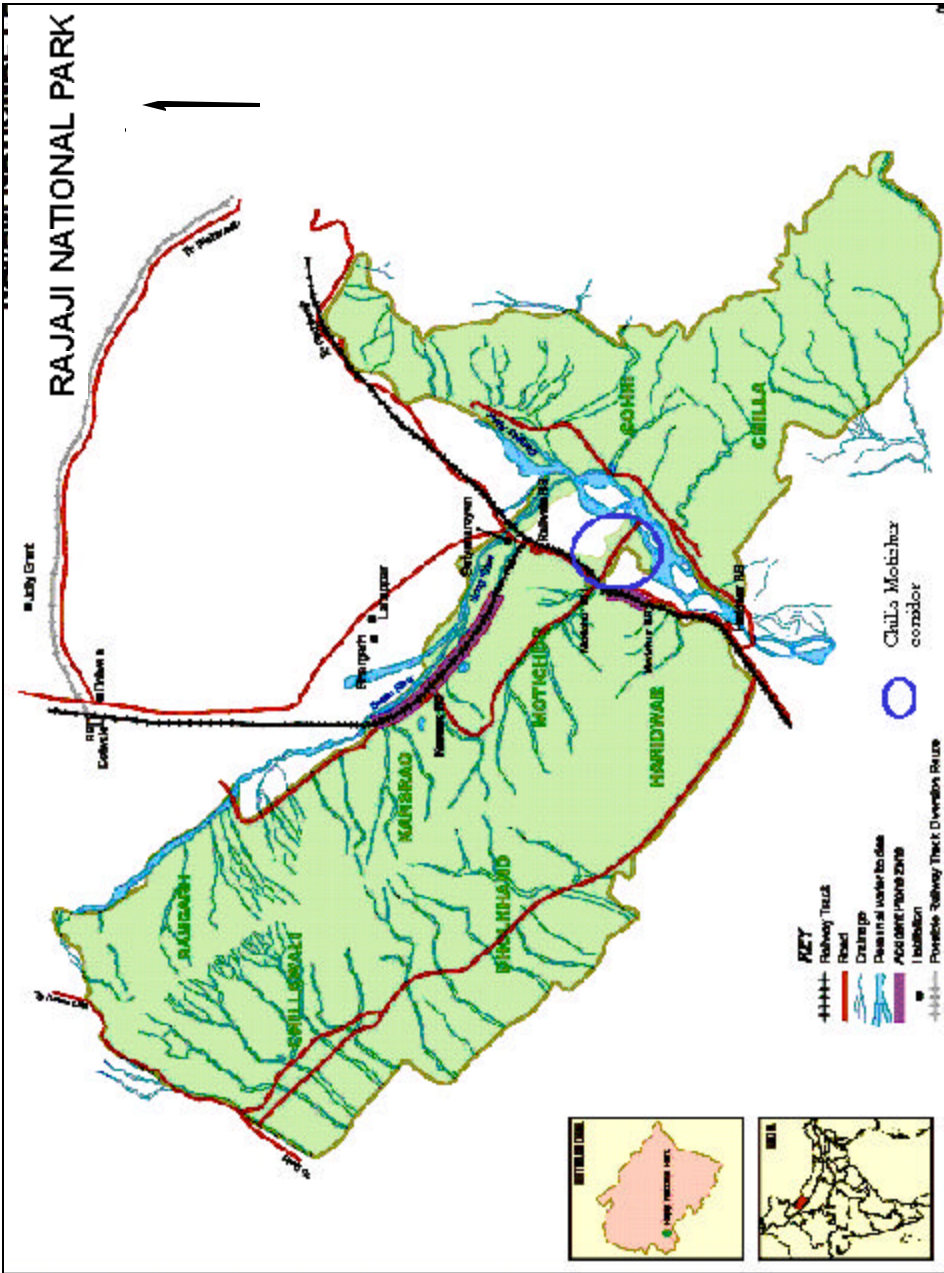
Figure 2: Rapid Action Project site, Rajaji National Park

The RAP was conducted between Haridwar railway station and Kansrao railway station and towards Doiwala railway station up to the last forest patch, covering almost 23 km of track stretch through the forest. The main vulnerable section of track for animal mortality falls between this area from Motichur Railway Station to Kansrao Railway Station and two km ahead of Kansrao towards Doiwala Railway Station (Figure 2). Based on the elephant accident reports, the track can be divided into two stretches:

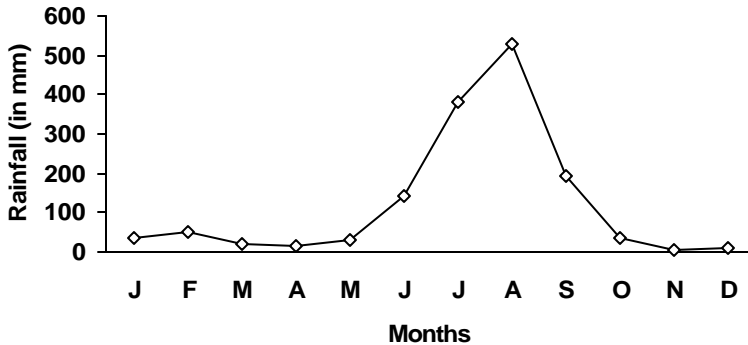
**Figure 3:** Mean monthly rainfall at Kansrao range office and Bhimgoda barrage Haridwar

There are three distinct seasons i.e. monsoon, winter and summer. The months of July to September receive maximum rainfall (Figure 3). Winter starts from November and ends in March. Summer lasts from April to June. The temperature varies between 45°C (maximum) during May to 3°C (minimum) during winter (Rodgers *et. al.*, 1990) (Figure 4).

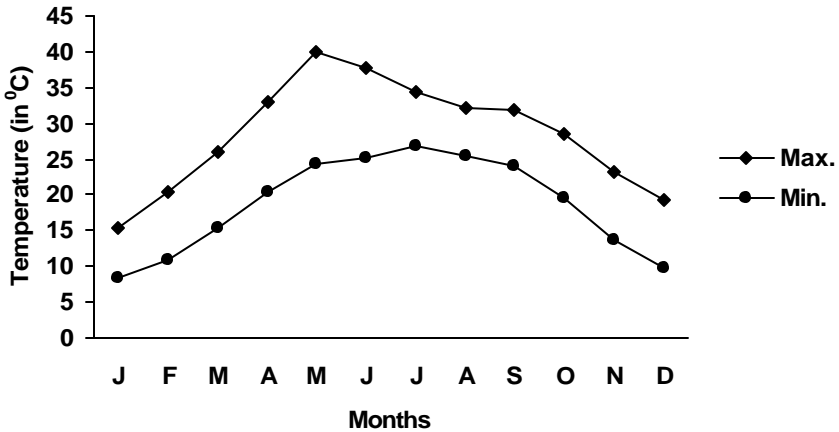
**Figure 4:** Mean monthly temperature of five years (1996-2000) at Dholkhand, RNP

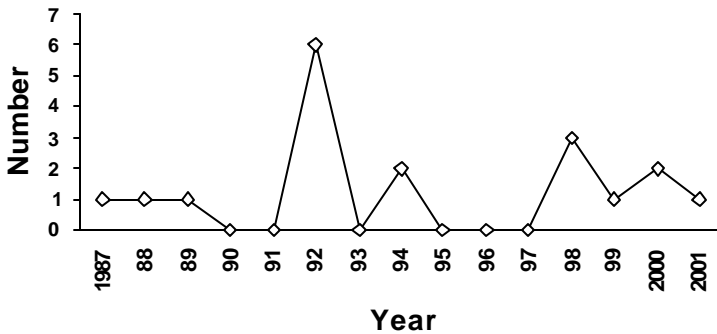
**Figure 8:** Trends of elephant mortality in train accidents in RNP

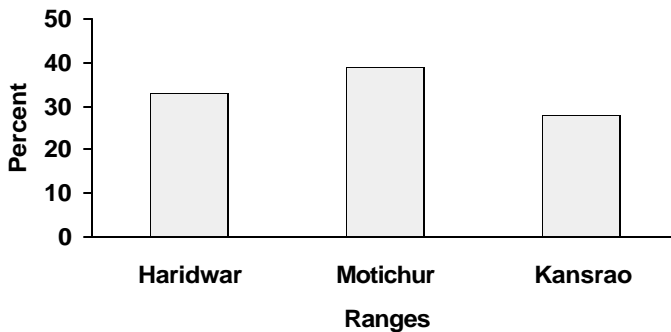
When elephant mortality figures were plotted for all three ranges (Haridwar, Motichur and Kansrao) separately, no significant differences were found (Figure 9). However, when elephant mortality was plotted for these three ranges against the track stretch critical for accidents in each range this yielded a different result. Such analysis shows that the mortality figure is much higher in the case of Haridwar range in comparison to its track stretch (Figure 10).

**Figure 9:** Range-wise elephant mortality by train accidents in RNP

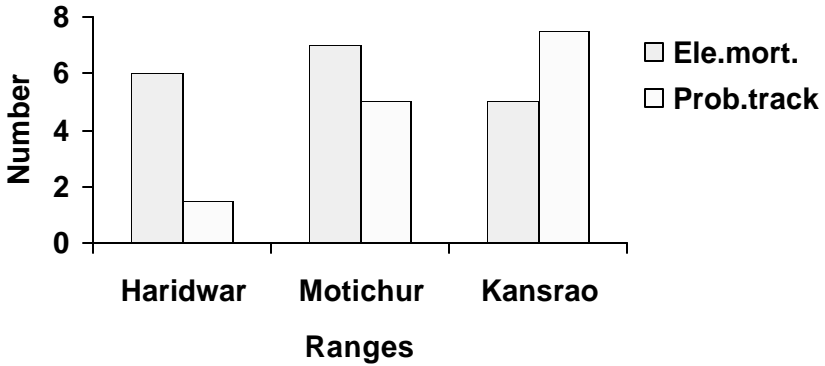
**Figure 10:** Elephant mortality in response to problematic length of railway track (in km) in different ranges

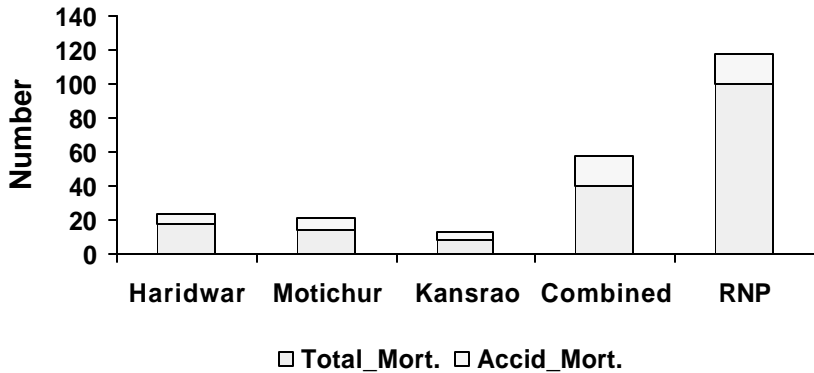
**Figure 11:** ELEphant mortality by train accidents in comparison to the total mortality of elephants in RNP

Elephant mortality due to train accidents were compared with the total elephant mortality in the Rajaji National Park. Mortality due to train accidents was found to be 18% of the total, a high figure due to a single reason (Figure 11). As mortality due to train accidents are occurring in only three ranges of RNP (the park has eight ranges overall), the data of total elephant mortality in those ranges were compared with it. Mortality by train accidents is 45% of the combined total mortality in these three ranges (Figure 11). Mortality by train accidents in Kansrao was the highest (63%) followed by Motichur (50%) and Haridwar (33%) as compared to the total mortality (Figure 11). This shows that elephant mortality by train accidents is locally alarming.

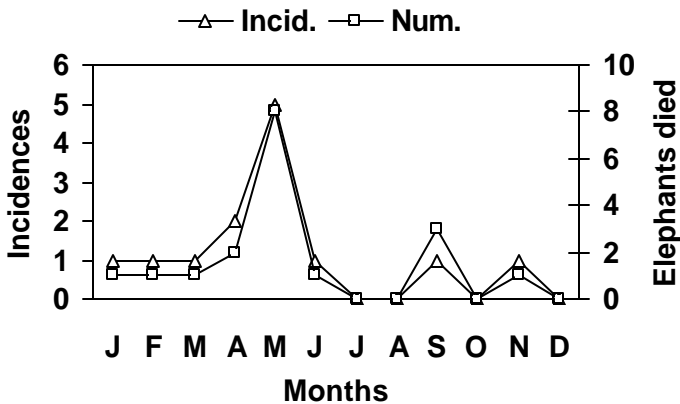
A month-wise pooled data analysis of elephant mortality by train accidents shows a clear pattern. Out of the 18 elephant deaths, 14 died between the months of January and June (Figure 12). The figure was

**Figure 12:** Seasonal trend of elephant mortality by train accidents in RNP

highest in the month of May. Incidents of accidents also showed the same pattern. Most of the mortality occurred during the summer period when there is scarcity of water in the area. The availability of perennial water sources on the northern side of the railway track might be a possible factor influencing elephant movement and causing accidents.

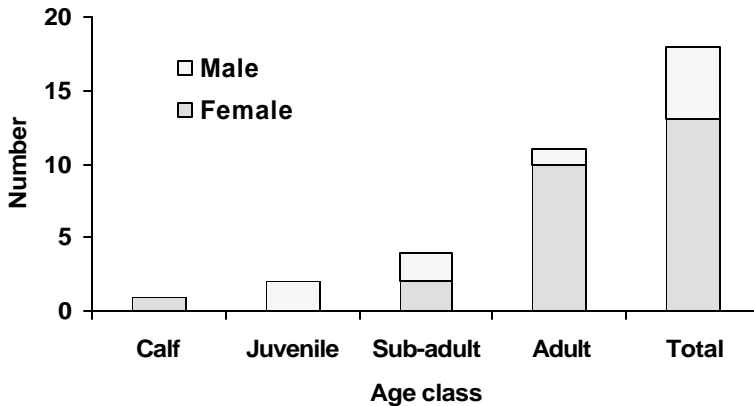
Elephant mortality by train accidents when plotted in different age and sex classes yielded notable results. The combined mortality in all age groups in case of females was found to be higher than males (Figure 13). Among adults, the mortality of females was found to be very high as compared to the mortality of males. Most of the females that died were in the breeding age class. This mortality of females in the breeding age group could have a great impact on the population.

Figure 13: Mortality pattern in age and sex class of elephants by train in RNP

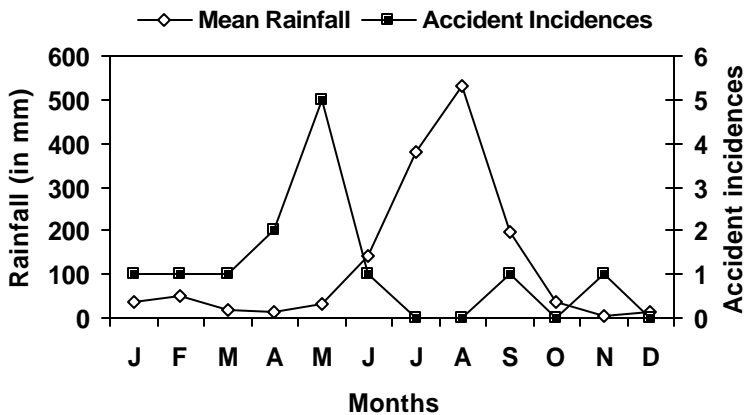
In and around Rajaji most of the rainfall occurs between June and September. July and August are the months of highest rainfall. When elephant mortality due to train accidents are plotted against the mean monthly rainfall in the area, there is an inverse relationship between them (Figure 14). When rainfall increases after the month of June, accident

Figure 14: Mean monthly rainfall and elephant accident incidences by train

related mortality shows a decline and during the dry period when rainfall decreases, mortality increases. With an increase in rainfall, water availability increases throughout the park and elephant movement takes place in different areas (Thouless 1995). Congregation to certain areas for perennial water sources during summer (Funston *et. al.*, 1994; Williams *et al.*, 1998) ends after rainfall, which might have an impact on mortality due to train accidents. Rainfall and water availability have been found to influence elephant movement (Easa 1988; Thouless 1996).

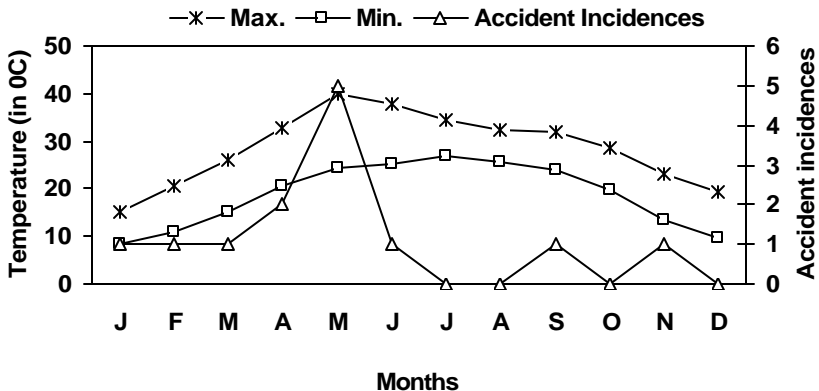
When the monthly mortality figure was plotted against the mean monthly temperature (available from Dholkhand range) both showed a similar peak in May (Figure 15). With an increase in temperatures from March, mortality also increases, while after July when there is decline in temperatures and a corresponding decrease in accident related mortality.

**Figure 15:** Mean monthly temperature and elephant accident incidences by train in RNP

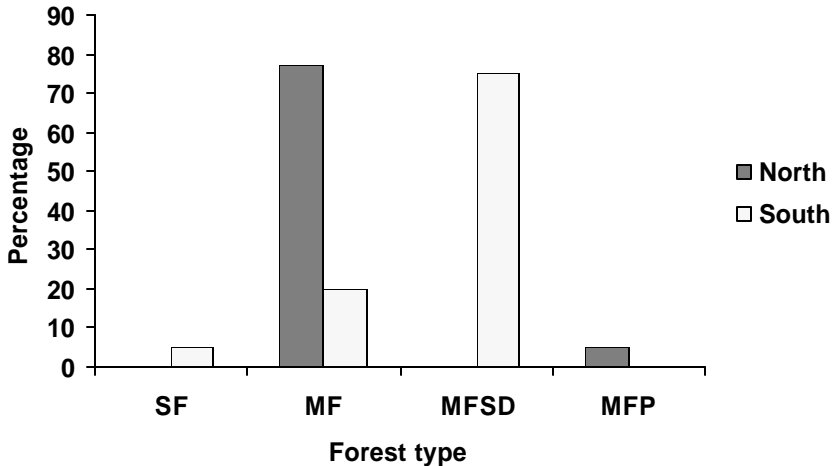
Vegetation type on the southern side of the railway track was found to be dominated by Sal (*Shorea robusta*), whereas in the northern side vegetation was mostly Mixed (Figure 16). In the south, 75% of the total plots were of Mixed Forest dominated by Sal, 5% pure Sal Forest and 20% Mixed Forest. In the northern side, 77% of the plots were of the Mixed Forest type, 5% Mixed Forest with Plantation and 18% was either riverbeds or open ground.

**Figure 16:** Broad forest type on both sides of the railway tracks in RNP

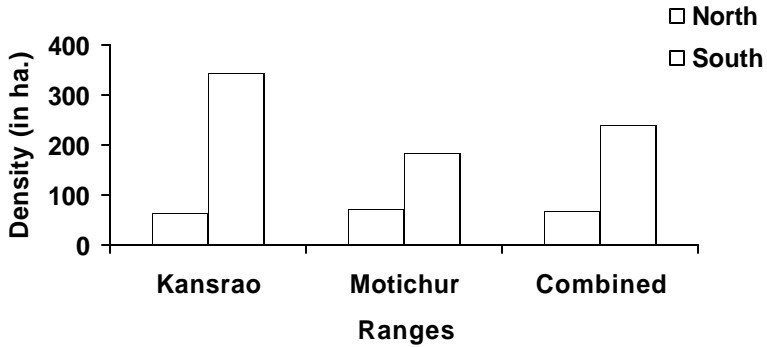
The density of food species among trees was found to be higher to the southern side of the track than the northern side through the park area (Figure 17). The food species among shrubs were also found in higher

**Figure 17:** Elephant food species (tree) on both sides of the railway track in RNP

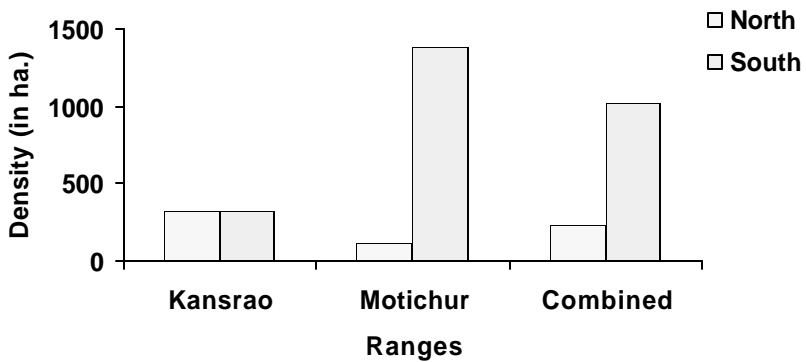
density to the southern side of the railway track in Motichur and in a combined analysis (Figure 18). In Kansrao the density on both sides of the track were found to be equal.

**Figure 18:** Elephant food species (shrub) on both sides of the railway track in RNP

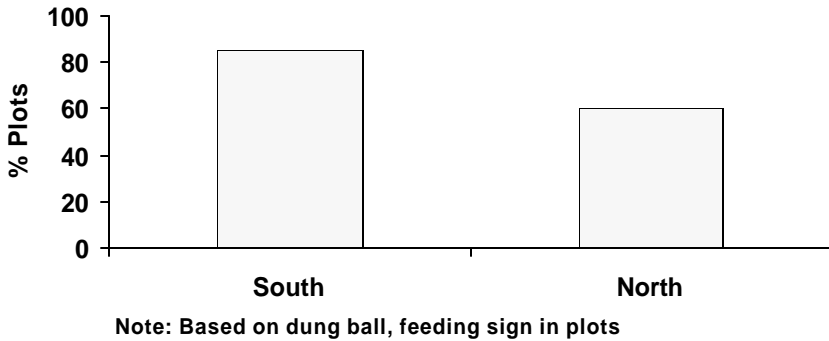
**Figure 19:** Utilization of the area by elephants on both sides of the railway track

Data on secondary signs of elephant presence (feeding sign, dung piles) in plots were also collected. When any such sign was present, plots were considered to be utilized. Areas on both sides of the railway track were compared. To the southern side of the railway track 85% of the plots were found utilized, whereas in the northern side only 60% of the total plots were utilized (Figure 19).

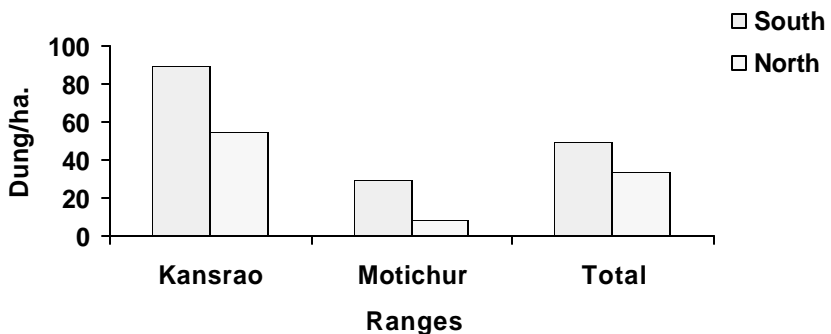
**Figure 20:** Utilization of area by elephants based on the dung density on both sides of the railway track

The density of elephant dung collected during each transect in a 2m belt were analyzed to compare the utilization by elephants. The dung density overall as well as in Motichur and Kansrao ranges were found to be higher on the southern side of the railway track than on the northern side (Figure 20).

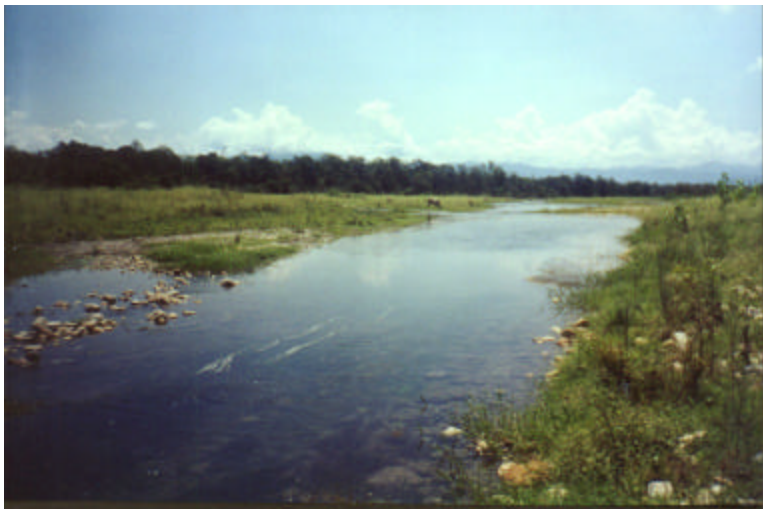
**Figure 21:** River Suswa: a perennial source of water to elephants during the dry season

The distance of river Suswa near Kansrao Range office varies from 609m to 870 m at certain places. The river Suswa, after joining the river Song, flows parallel to the railway line on the northern side, at a distance of between one to two km. There are not less than five to six perennial nallahs, tributaries or distributaries of these rivers. The whole area on the northern side of the track is very moist due to the presence of water even during the summer season.

On all six transects on the northern side of the railway track, perennial water bodies were found. The important perennial rivers are the Suswa (Figure 21) and the Song. There are several other perennial nallahs, which flow parallel to the railway track some of which are less than 15m away from the track at several places. One such nallah flows along the track between telephone pole number 41/2 and 43/15 on the north side at a distance of between 10 to 50m (Figure. 22). Transect no. 3 on the northern side crossed seven perennial nallahs.

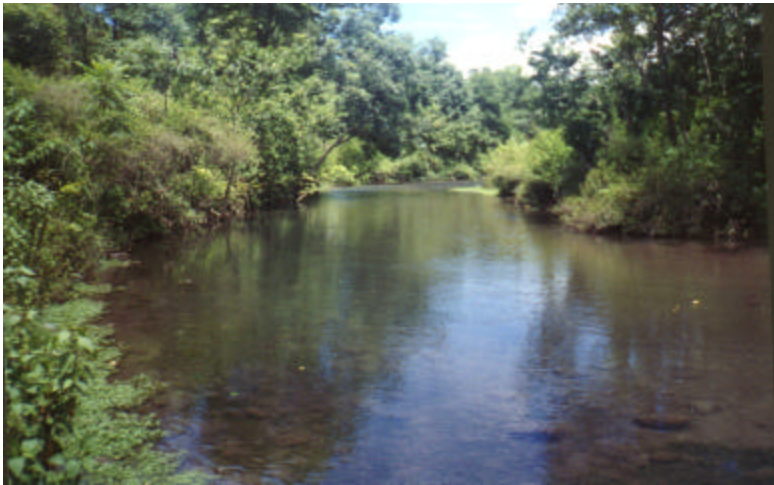
**Figure 22:** Nallah: a part of a perennial water body on the northern side of the railway track.

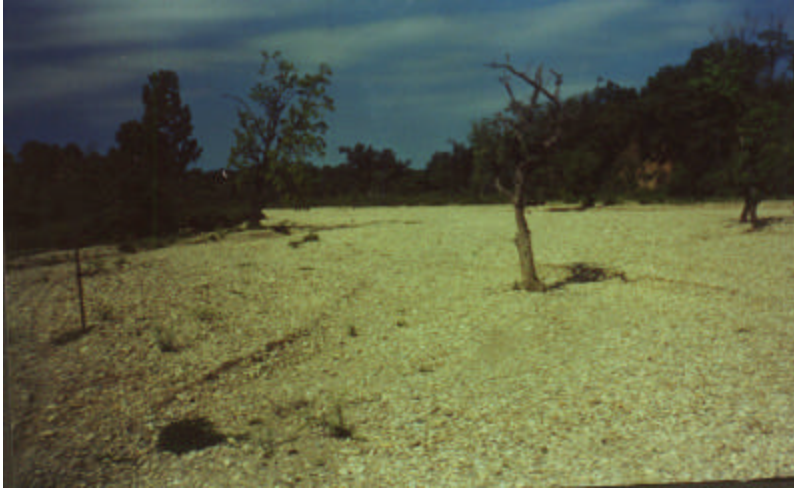
On the other hand on the southern side of the railway track, perennial water bodies were not found on any transects. Dry riverbeds are the features of the areas south of the railway track (Figure23). On the south-western side of the railway track there are two perennial water bodies that fall in the Motichur range. Motichur Rau, which has water during summer, is situated at a distance of four to five km from the track. The Koilpura waterhole is the other perennial water body situated at a distance of

**Figure 23:** Dried Rau: a common feature of the areas south of the railway track

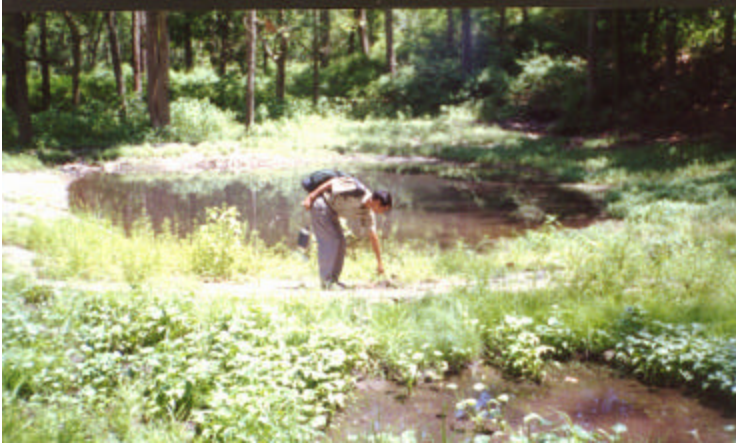
seven to eight km from the track. In Kansrao range on the southern side of the railway track, there are two small perennial waterholes situated at a distance of 600-700m from the railway track (Figures 24 a & b). Fresh elephant signs such as dung piles and footmarks were found near these waterholes. These waterholes are approximately three km apart from each other. They are in a very bad condition. Water is spilling out and siltation has taken place. Apart from these waterholes, the whole area on the southern side is completely dry during the summer season.

**Figure24a:** Perennial water hole on the southern side of the railway track in Bahera V block, Kansrao.

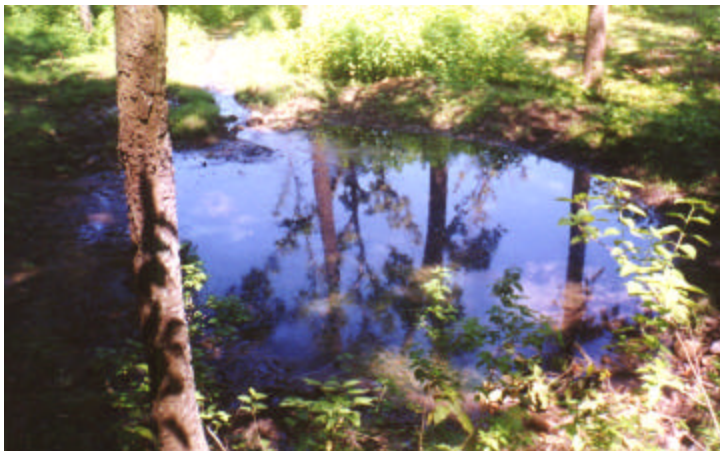
**Figure 24b:** Perennial water hole on the southern side of the railway track in Koilpura III block, Kansrao

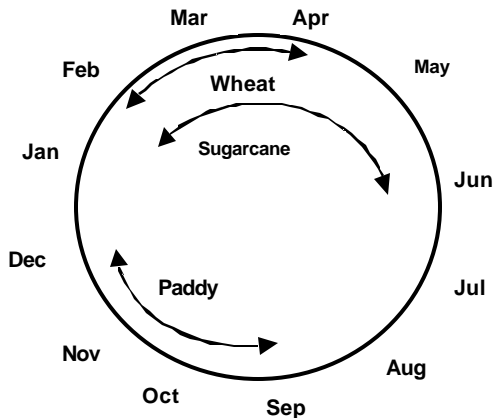
Figure 26: Crop depredation pattern in villages close to northern boundary

is caused mainly by loners. Depredation in the villages on the boundary of the Kansrao and Barkote ranges is high as compared to the villages close to Raiwala and Satyanaryan. Depredation of wheat was noticed as being the highest, followed by sugarcane and paddy. The peak period of wheat depredation was found to be between the months of February and April. Depredation of sugarcane takes place more or less throughout the year but is highest between February and June. Paddy depredation occurs during the months of September and December (very few). In the villages on the boundary of the Kansrao and Barkote ranges, wheat depredation is the highest followed by sugarcane. In villages close to Raiwala and Satyanaryan wheat depredation is the highest followed by paddy. The raiding group size also differs in different seasons. During February and June the raiding group size is larger (4-25 elephants) than in the monsoon and winter.

In villages, damages to banana trees and jackfruit have also been noticed. But these trees are few in number. Crop depredation patterns and season coincide with the elephant mortality period in the area. The peak depredation period is between the months of March and May during which time mortality by train accidents is also high.

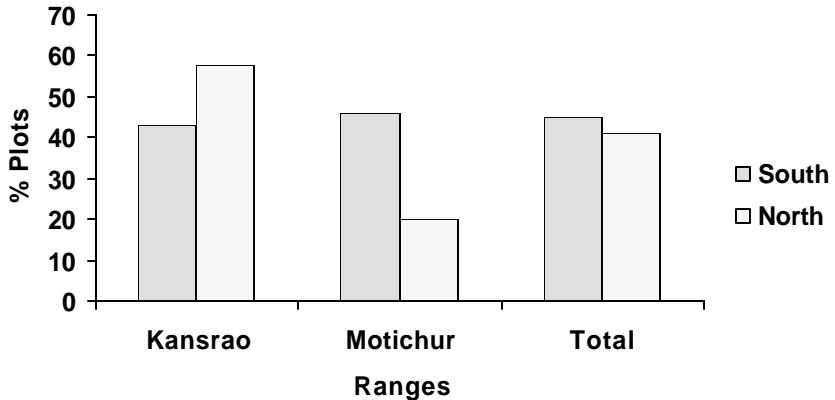
For human disturbances, factors such as human presence, cattle presence, and cattle dung in plots were taken as indicators. Plots were classified as being disturbed if these indicators were present in them. When data was compared for either side of the track, no differences were found (Figure 27).

**Figure 27:** Disturbances on both sides of the railway track in RNP

do not have any role on elephant movement from the south of the track to the north. Dung density was also found to be higher on the southern side of the track relative to the northern side. There were no differences in disturbances on either side of the track. Rainfall showed an inverse relationship with elephant mortality due to train accidents; mortality decreasing as rainfall increased. Temperature showed a direct correlation with the monthly mortality trends of elephants due to train accidents; peak mortality coinciding with very high temperatures. Differences in water availability on both sides of the track during the summer season indicate that water might be the main influencing factor responsible for movement of elephants from the south to the north side. The crop raiding season also coincides with the maximum mortality period; crop raiding being high during the period of maximum mortality.

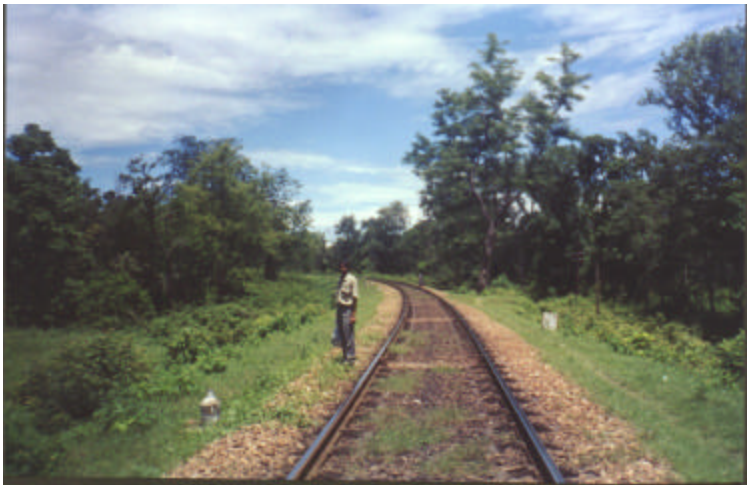
**Figure 28:** Turning: a critical section on the track where chances of elephant mortality is high due to train accidents.

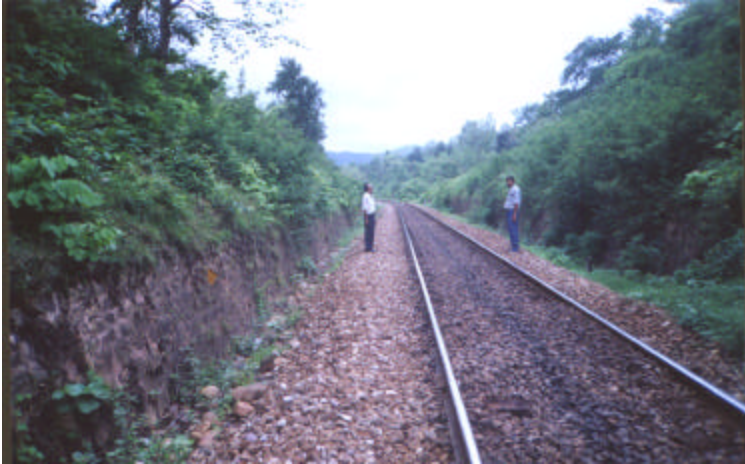
**Figure 29:** Mound; elephants are prone to be trapped in areas with such land features

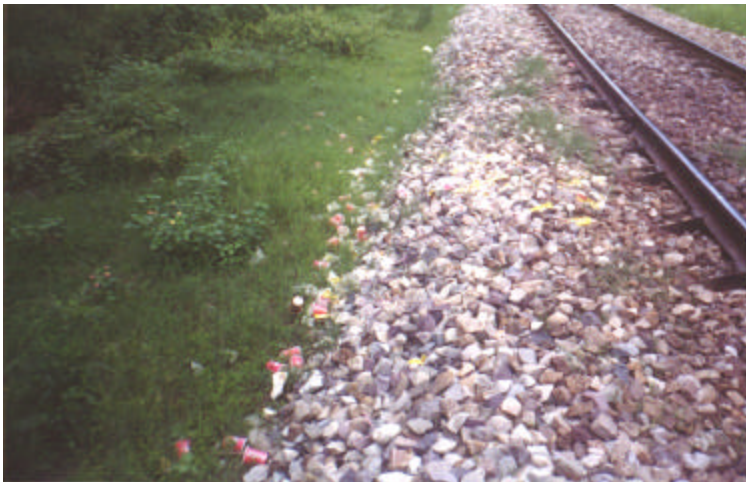
While collecting data on the railway track in Rajaji National Park, the RAP found waste disposed at more than 22 places from the Shatabdi Express (Figure 30). Several kinds of non-biodegradable substances were recorded along the track at many places. Passengers from other trains are also throwing waste material on park grounds. Waste includes mineral water bottles, cold drink cans, sauce pouches, tea bags,

**Figure 30:** Garbage disposed by caterers of Shatabdi Express along the railway track in park area is attracting wild animals.

polythene bags, residue of edible items and non-biodegradable substances. This waste attracts many wild animals including elephants, chital, and wild boar onto the track. Animals have been seen eating food waste and other articles on the track in the evening. Polythene bags have been recorded in elephant dung in the Kansrao area. Thus, waste disposal is not only dangerous as it attracts animals onto the track, thereby increasing the chances of animal mortality due to train accidents, but additionally, mortality caused by ingestion of plastic and polythene bags and subsequent intestinal blockage is also likely.

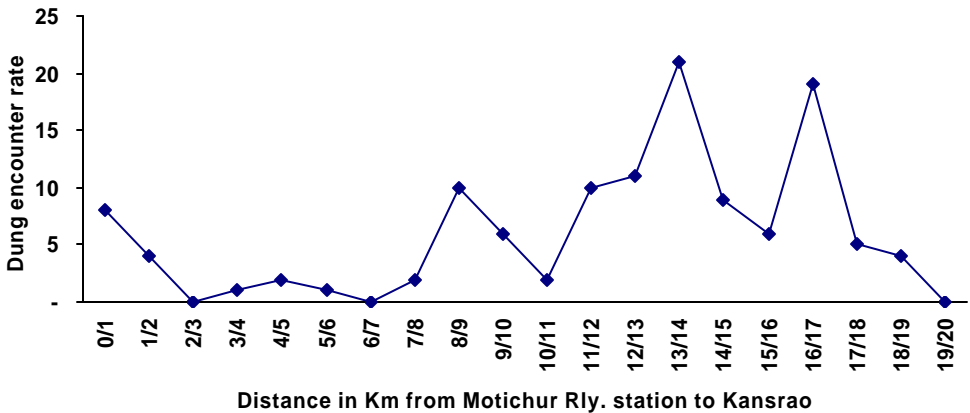
movement were identified (Figure 31). The first such zone was found after Motichur railway station towards Raiwala. One km of track stretch up to telephone pole no. 33/9 had a high dung encounter rate. The second such zone was between telephone pole no. 40/7 to 41/8. This place is approximately eight km from Motichur railway station and extended for nine kms. The third such zone (the highest among all) was found between telephone no. 43/11 to 49/2 up to Kansrao railway station. This stretch was around six km.

**Figure 31:** Crucial movement zones across the track in RNP (based on dung encounter rate)

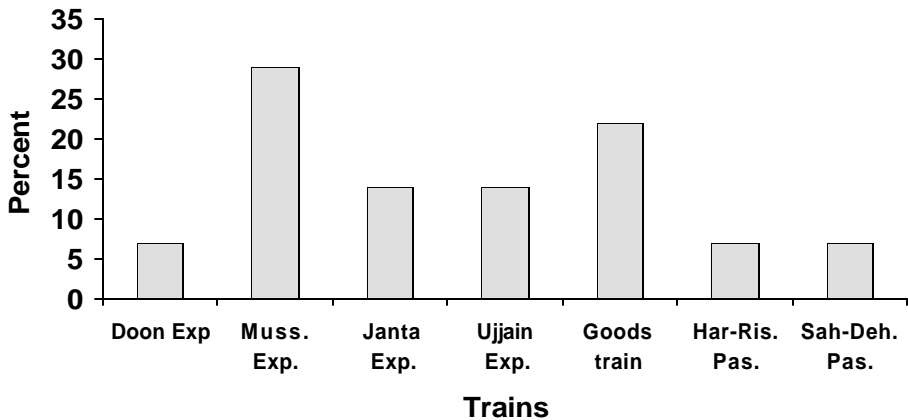
The trains which have been responsible for elephant related accidents are; Doon Express (both up and down), Mussorie Express (going to Delhi), Janta Express (going to Varanasi), Ujjain Express (going to Dehradun), Haridwar-Rishikesh passenger, Saharanpur - Dehradun

**Figure 32:** Percentage involvement of problematic trains in accidents in RNP

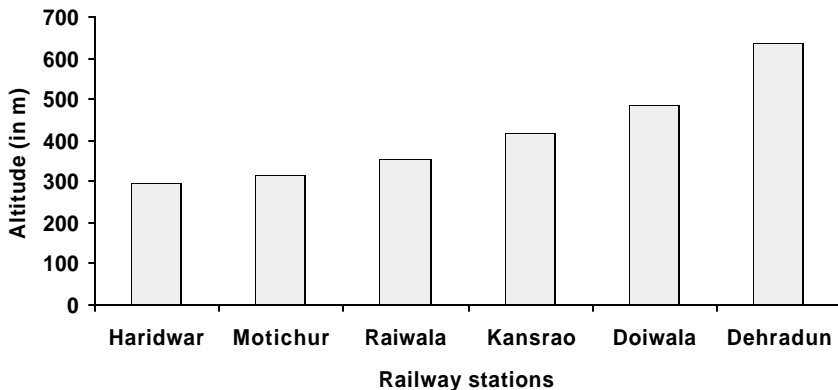
**Figure 33:** Difference in altitude between different railway stations in RNP
